Manhole Inspection Summary

Manhole # S23UU1007MH

Location Address: **209 EDGEVALE RD**

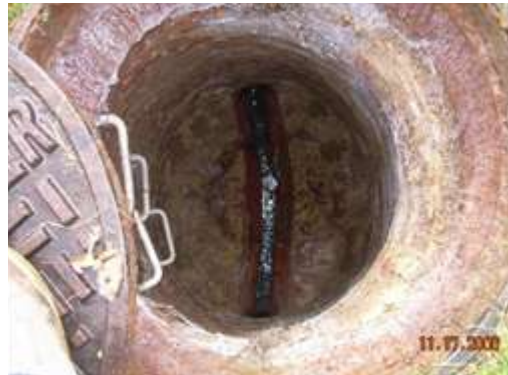
Top View

Frame offset. Evidence of surcharge - Bench debris.

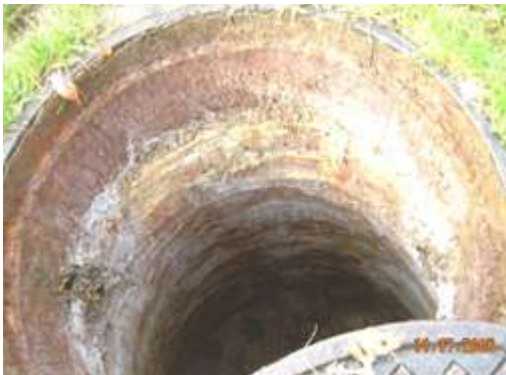
Defect

Frame offset. Adjustment deterioration and infiltration. Barrel infiltration.

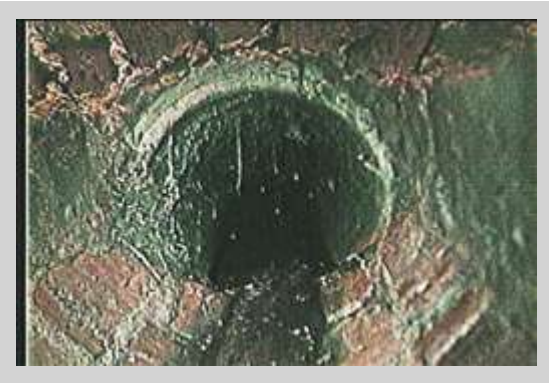
8 in. Circular Gravity Sewer Pipe Out @ 12 O'Clock

Channel root intrusion.

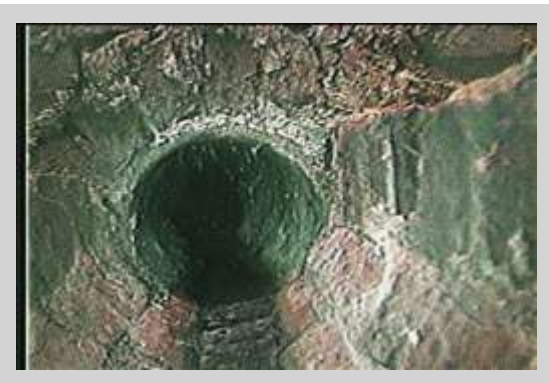
8 in. Circular Gravity Sewer Pipe In @ 7 O'Clock

Barrel deterioration and infiltration. Channel deterioration.
